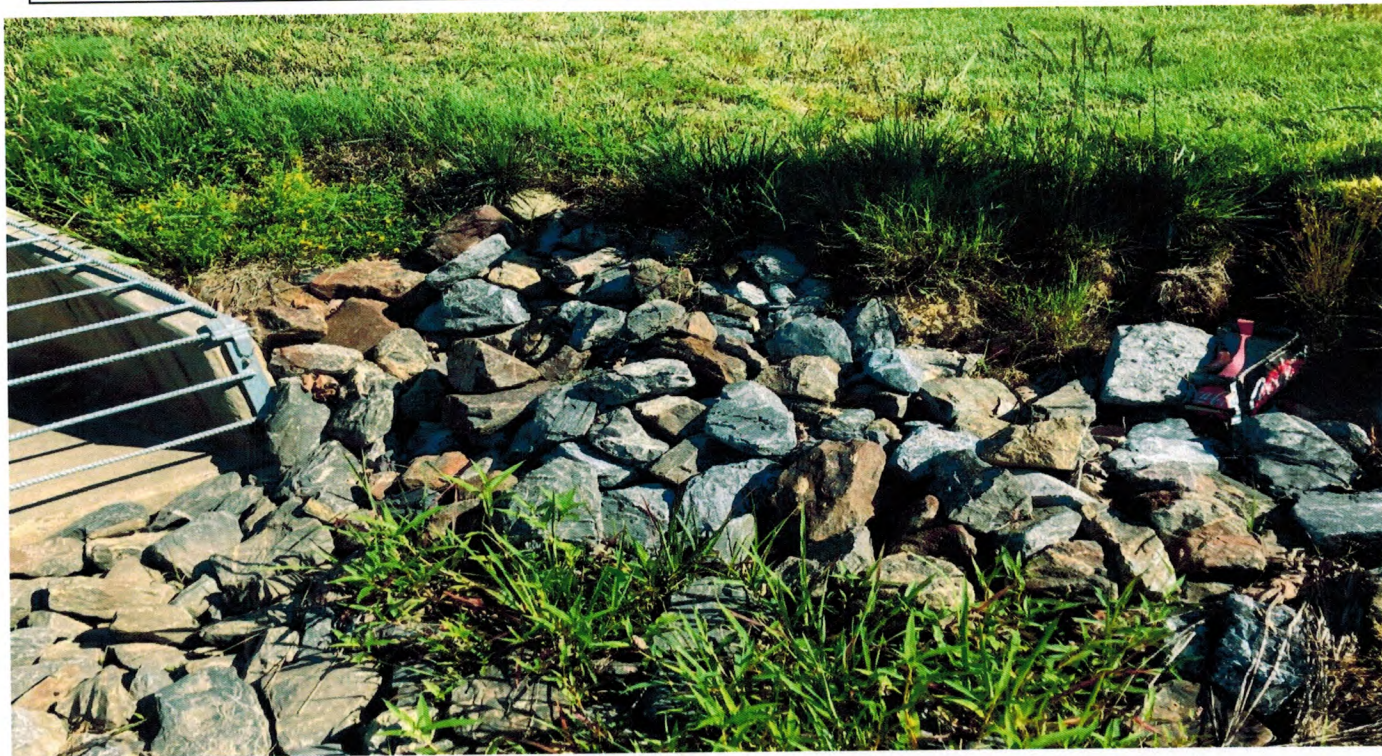
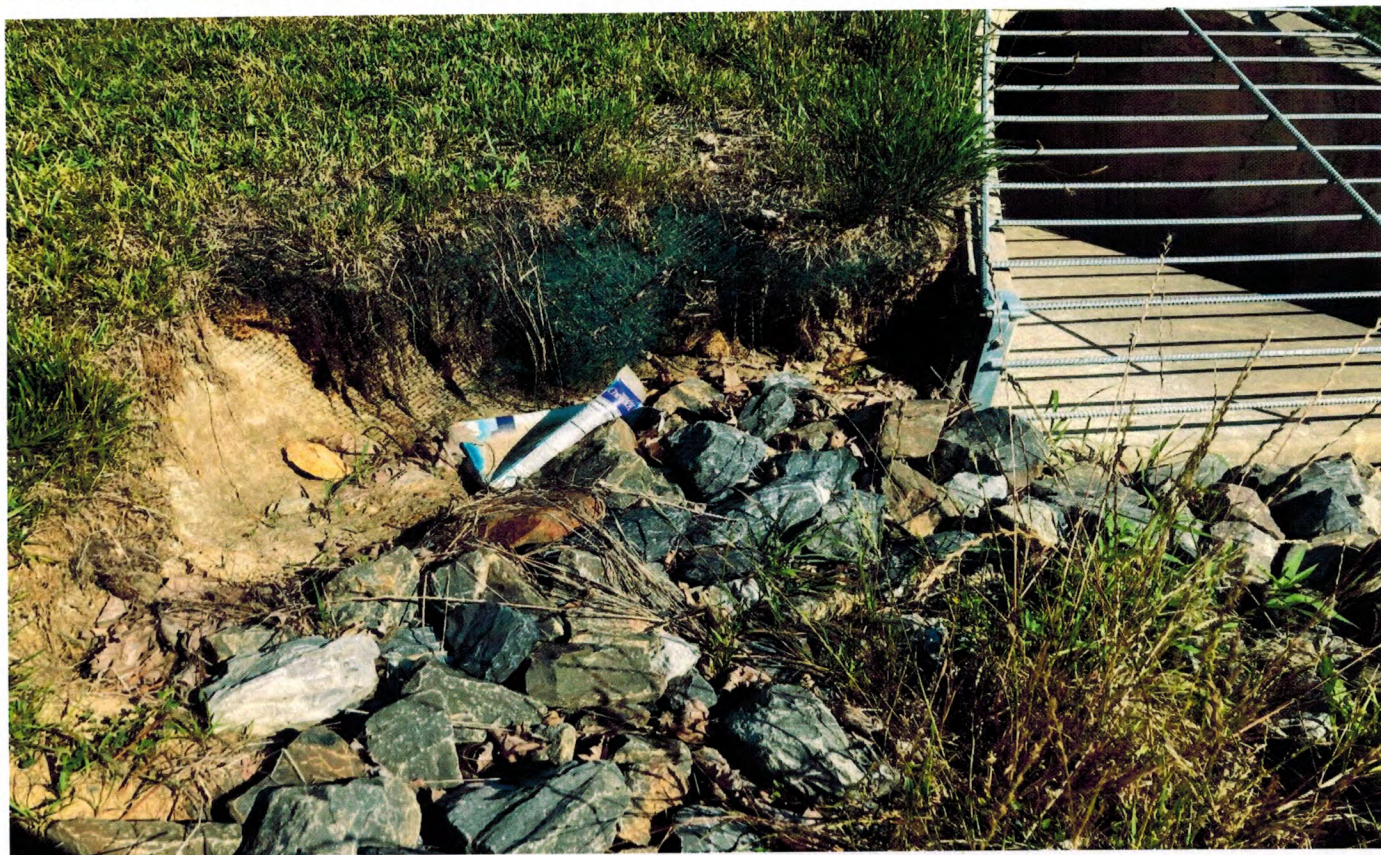
DIRECTIVE: Fix the minor erosion on both sides of the rip-rap lined inlet forebay area.
